Manhole Inspection Summary

Manhole # S39A2_015MH

Insp Date: **12/23/08 4:19 PM**

Location Address: **Jeffrey-6th Alley**

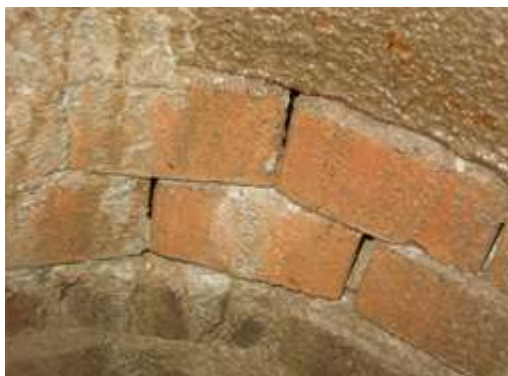
Defect 2

☐ Parged Height: **4** (in.)

Infiltration: ☐ None ☒ **Joint** ☐ Cracks ☐ Mortar ☐ Roots ☐ Wall

Open joints in Chimney

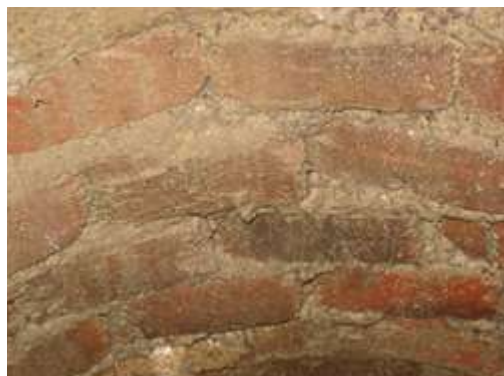
Defect 1

Condition: ☐ Sound ☐ Cracked ☒ **Root Intrusion** ☐ Loose Brick ☐ Deteriorated

Infiltration: ☐ None ☐ Joint ☐ Cracks ☐ Mortar ☐ Roots ☒ **Wall**

Root intrusion in Barrel

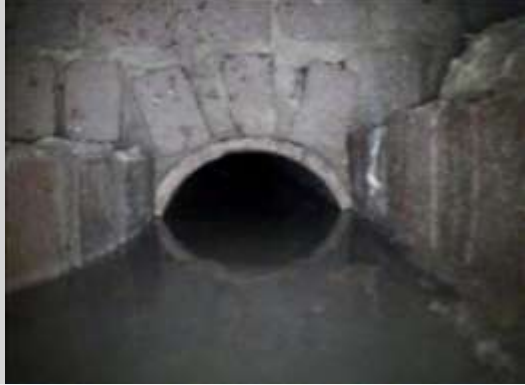
12 O'Clock Outflow

8 in. Circular Gravity Sewer
Pipe Out @ 12 O'Clock

Pipe Height: **8.4** (in.) Rod and Bar (Angled)
Pipe Material: **Clay** ☐ Pipe Lined
Invert Depth: **10.60** (ft.) Flow Characteristics: **Slow**
Deposits: ☒ None ☐ Mud ☐ Sludge ☐ **Debris** ☐ Grease
Silt Depth: (in.) Deposits Extent:
Infiltration: **None** Pipe Seal Cond: **Sound**

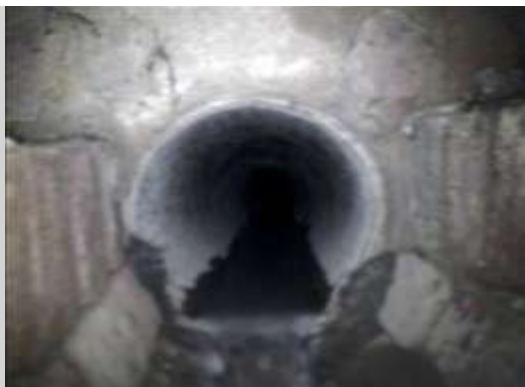
6 O'Clock Inflow

8 in. Circular Gravity Sewer
Pipe In @ 6 O'Clock

Pipe Height: **8.4** (in.) Rod and Bar (Angled)
Pipe Material: **Clay** ☐ Pipe Lined
Invert Depth: **10.30** (ft.) Flow Characteristics: **Slow**
Deposits: ☒ None ☐ Mud ☐ Sludge ☐ **Debris** ☐ Grease
Silt Depth: (in.) Deposits Extent:
Infiltration: **None** Pipe Seal Cond: **Sound**

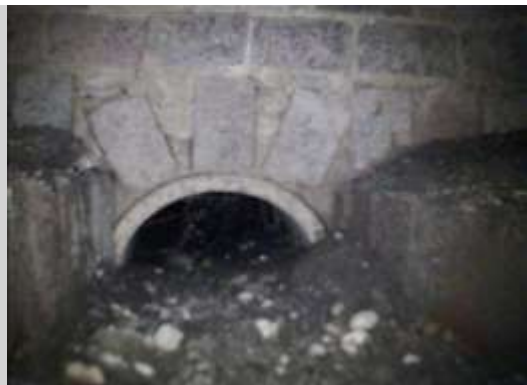
9 O'Clock Inflow

8 in. Circular Gravity Sewer
Pipe In @ 9 O'Clock

Deposits: ☐ None ☐ Mud ☐ Sludge ☒ **Debris** ☐ Grease

Silt Depth: **4** (in.) Deposits Extent: **Heavy**

Connects To: **Dead End**
